Wood burning stove installation

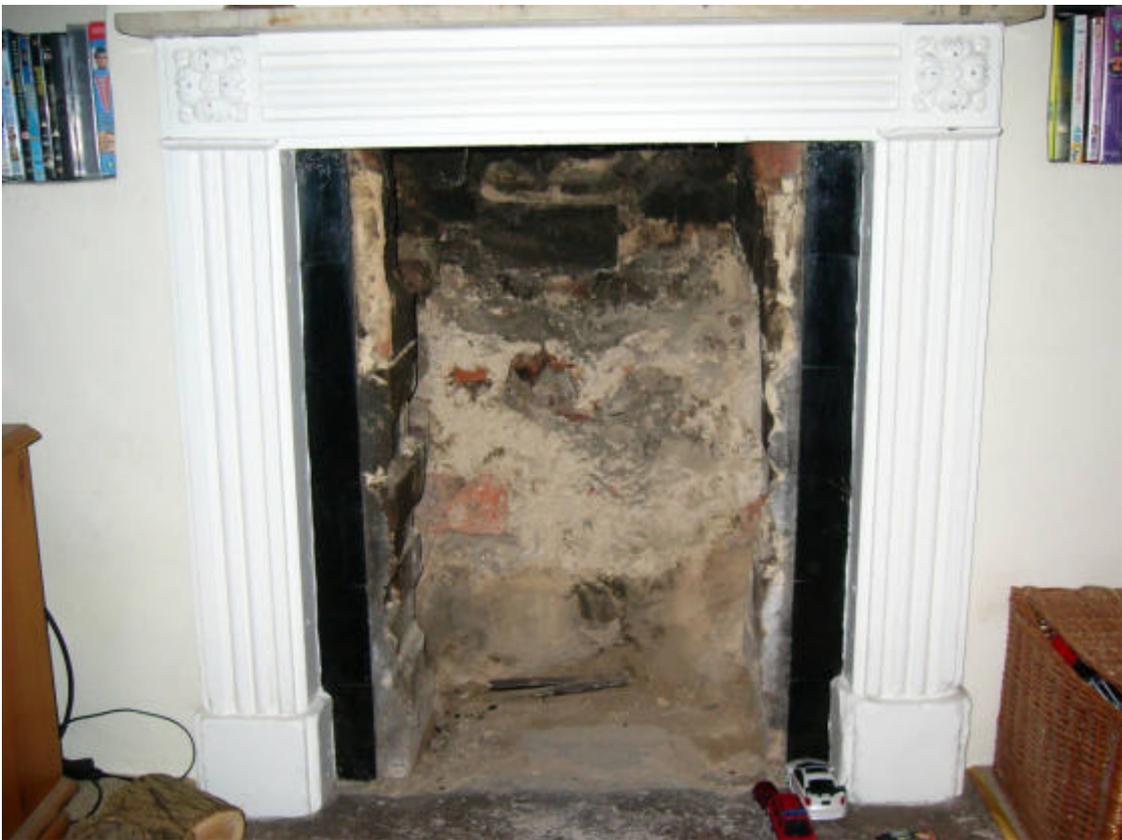
The fireplace and chimney were in bad condition. This meant that a major restoration would be required to return the fireplace to use as a conventional fire. The biggest problem was the chimney, which was no longer capable of safely containing hot combustion gases. The hearth itself had been damaged and modified to take a decorative Victorian fireplace. Behind this was an accumulation of rubble, some of which had been placed there to support the Victorian fireplace and some from the chimney. The early Victorian stone surround was in good condition but was covered with several layers of paint. Figure 1 shows the stone surround and modern badly constructed hearth and rubble fill.

Figure 1. The original fireplace and rubble fill.

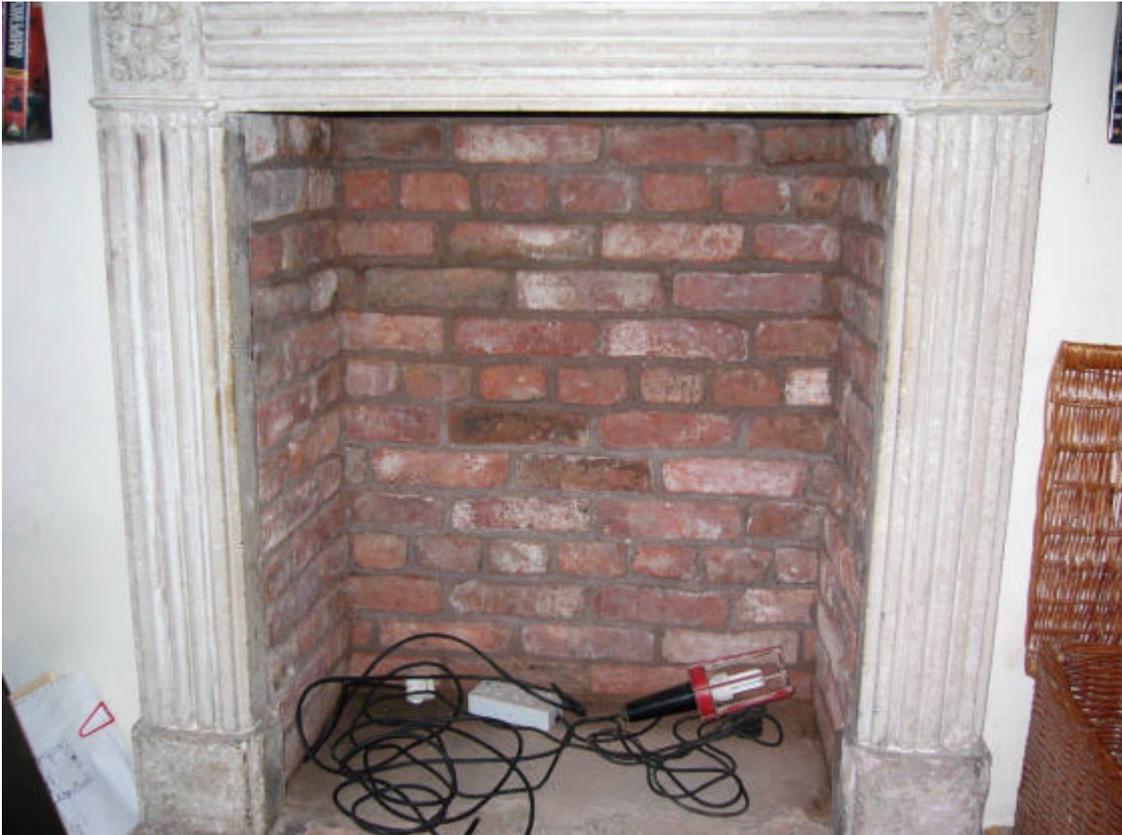
Figure 2. The new hearth and stripped fire surround.

Figure 2 shows the completed hearth with concrete base and stripped stone surround. Once the brickwork was complete, the metal work was installed to support the register plate. A frame was produced and fixed to the top of the hearth. The register plate can then be bolted to this frame. Importantly, the register plate can be removed to gain access to the chimney for maintenance.

After the fireplace was cleared, a concrete base was laid and the new hearth built using reclaimed bricks. The reclaimed bricks were handmade circa.1800 and sourced from a reclamation yard at a cost of £1 each. The type of brick bond chosen for the construction of the hearth was a variation of Old English Bond, commonly known as

Modified English Bond or English Garden Bond. This style was common in the period the house was built. English Garden Bond consists of rows of headers placed every fourth course as opposed to alternate courses as with Old English Bond. The mortar used in the construction of the hearth was a soft lime rich, cement, lime, sharp sand mortar mix with the ratio 1:3:9.

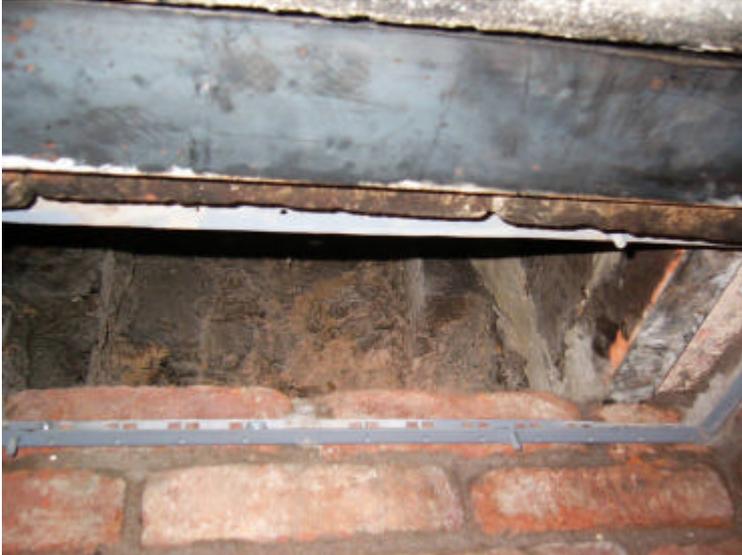
Figure 3 shows the register plate frame installed into the hearth. It is also possible to see the new steel lintel, fitted during the construction of the hearth.

Figure 3. The register plate frame.

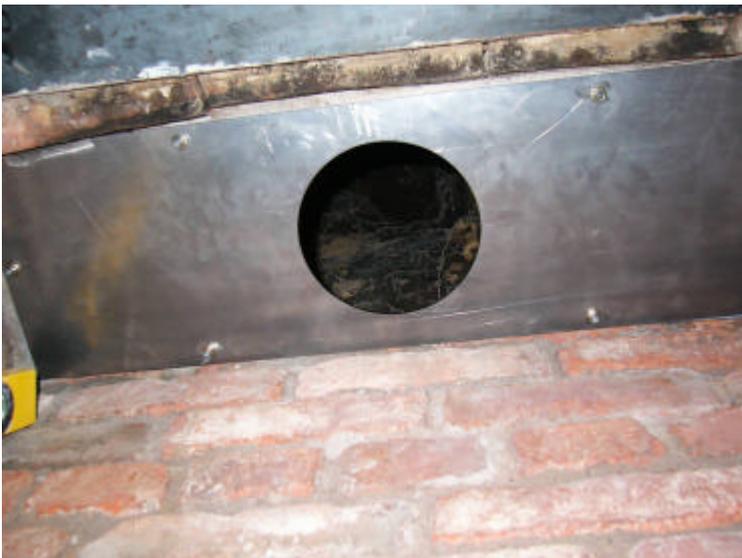
Figure 4 show the register plate in situ, bolted to the register plate frame. The plate itself was made from 4mm thick high quality laser cut steel, which could take the heat without warping and contain any further rubble falling from the chimney.

Figure 4. The register plate fitted into the hearth.

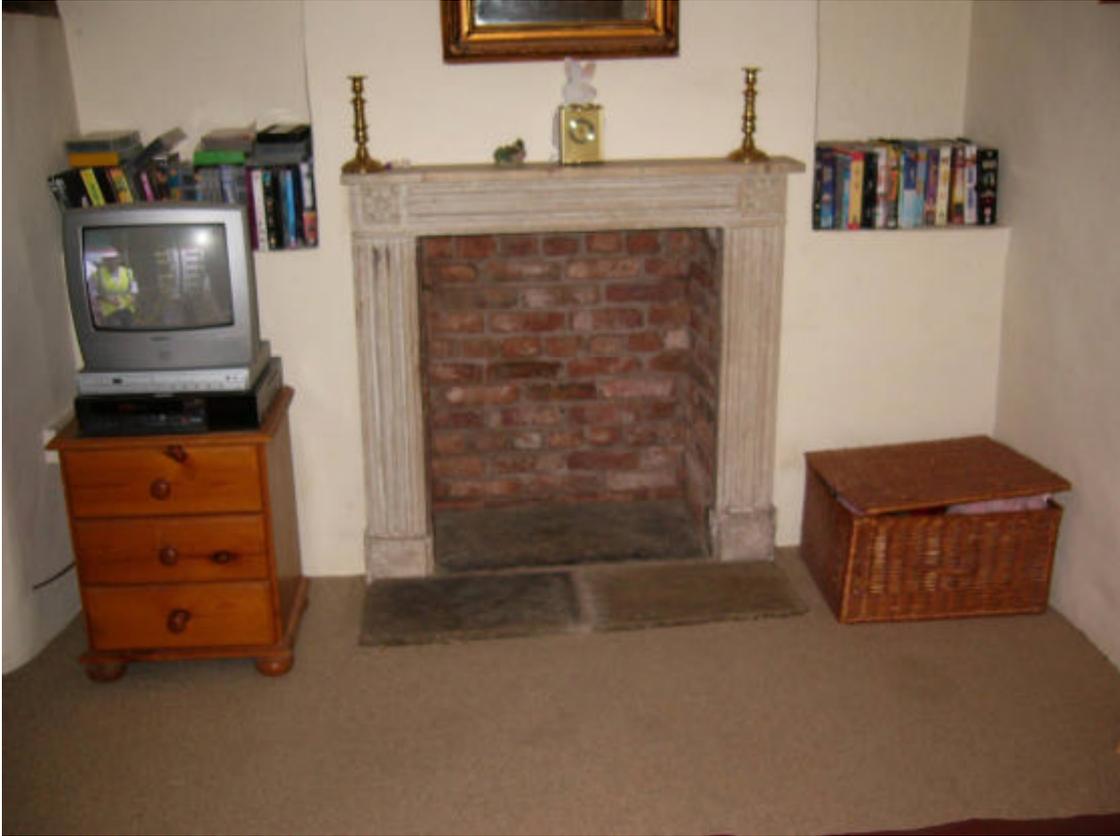
Figure 5 shows the finished fireplace with the hearth stones in place. The hearth stones were reclaimed York slabs, which are used extensively in period homes as flooring.

Figure 5. The finished fireplace.

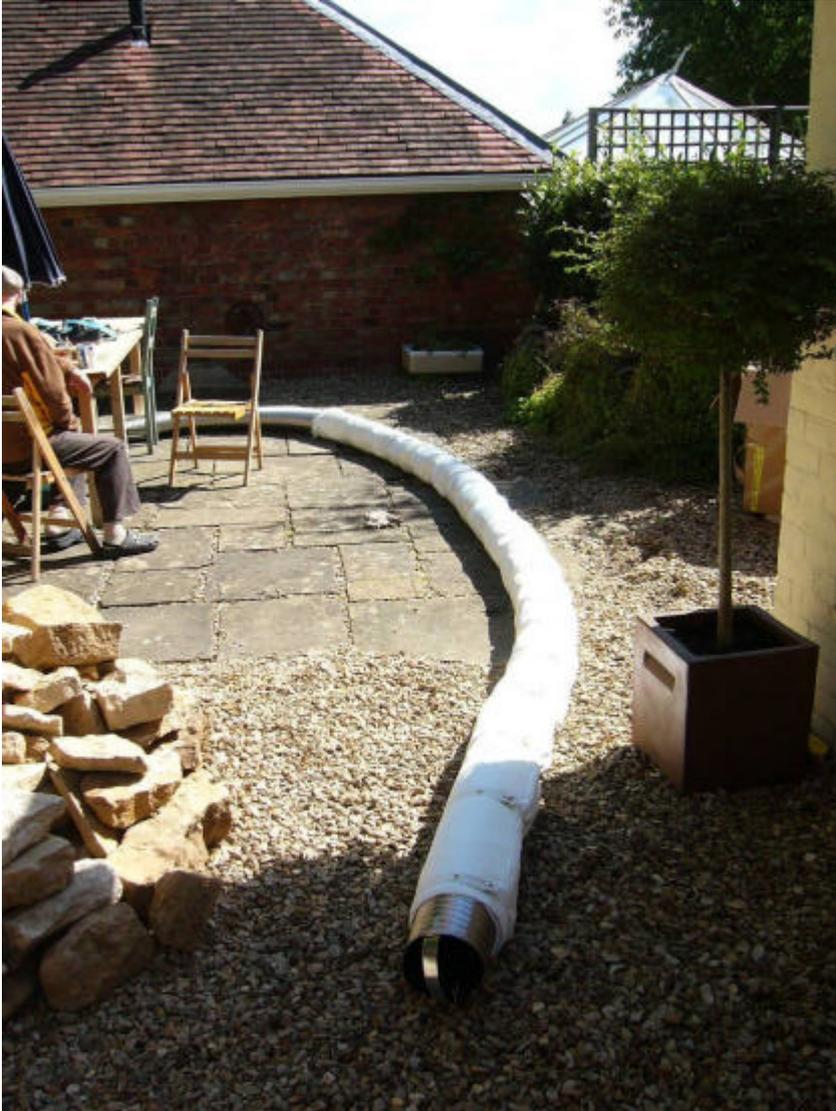
Figure 6. The flexible stainless liner and Chimwrap insulation.

Figure 6 shows the completed liner and Chimwrap insulation prior to installation into the chimney. The insulation material was secured to the liner with stainless steel ties at 300mm intervals along its length.

Due to the state of the chimney and because a modern multi-fuel stove was to be fitted, a chimney liner was required to contain the flue gases. The liner system chosen was a flexible double skin one piece stainless steel liner. The stainless steel liner was constructed from 904 grade stainless steel. This grade of liner is normally used in situations where the liner will be subject to very high temperatures or heavy condensate formation. To further protect the chimney walls from the higher flue gas temperatures generated by all modern multi-fuel stoves, the liner was fitted with insulation. The insulation chosen was Chimwrap, a woven glass blanket that fits around the liner. The main advantage to using Chimwrap is that it only 12mm thick. This was

particularly important in this case as the chimney was quite narrow towards the top.

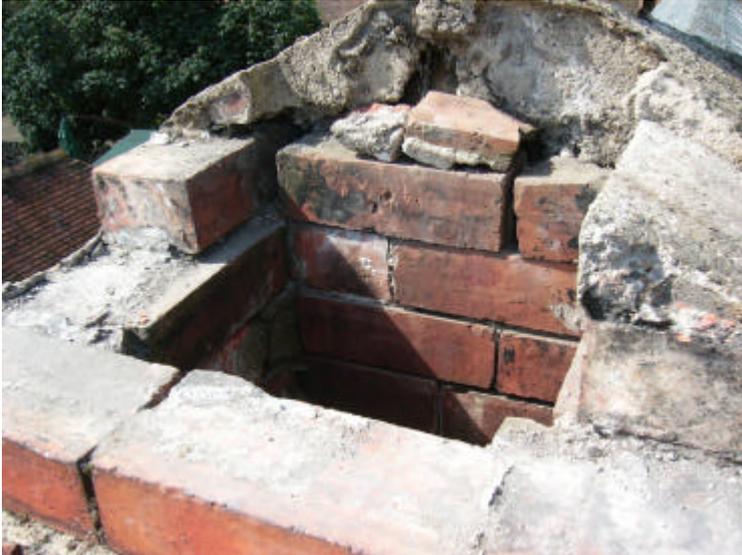
The chimney brick work needed attention prior to the insertion of the liner and top closing plate. When this was complete the liner was pulled up the chimney.

Figure 7. Chimney brickwork

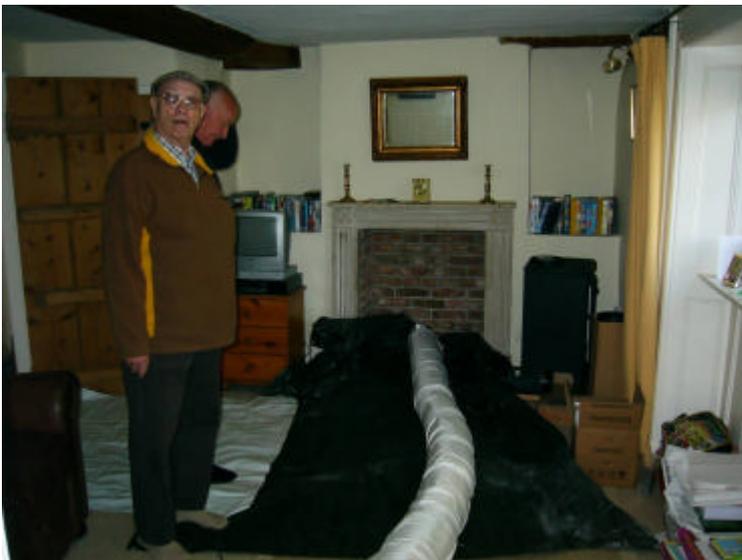
The liner and insulation being positioned prior to being pulled up into the chimney.

Figure 8. Liner being pulled up the chimney

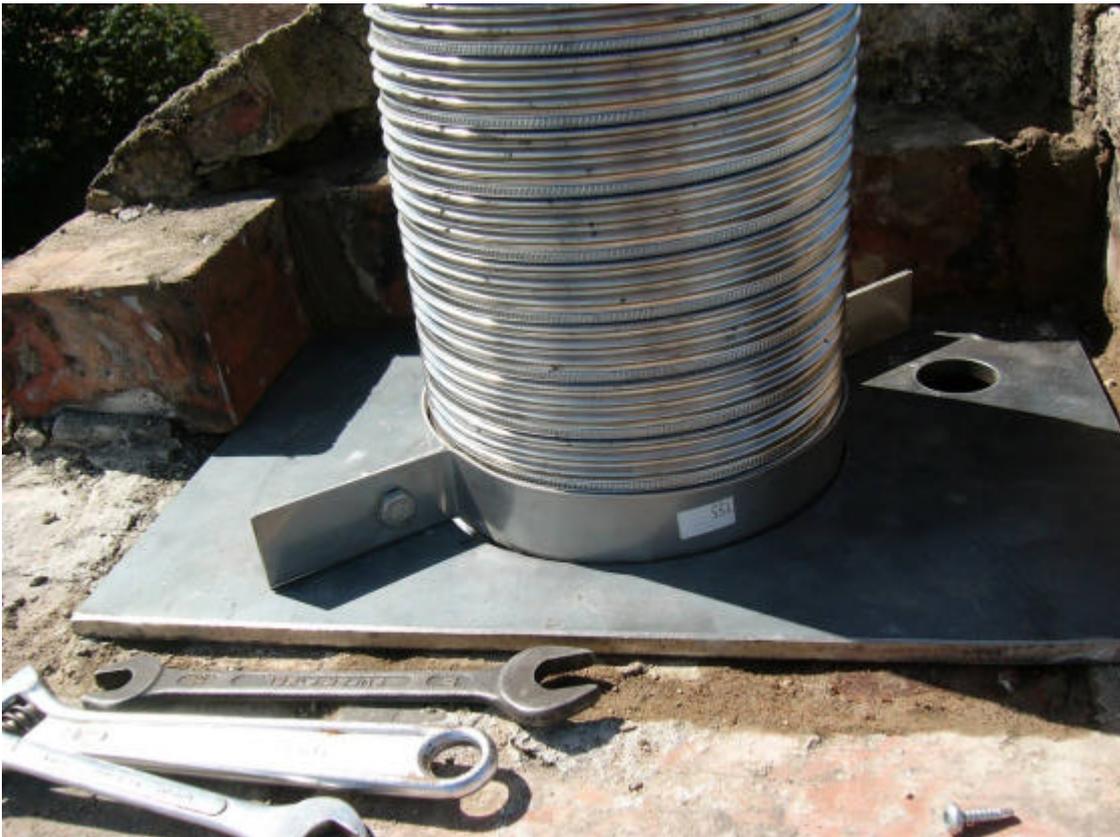
Once the liner and insulation had been inserted into the chimney, the 8 mm thick steel top closing plate was installed. In this installation the top closing plate was the main support for the liner and insulation. An alternative method uses a thinner top closing plate and requires the clamp to be held by the masonry of the chimney. The stainless steel clamp was then fitted to secure the uppermost part of the liner in place. The top closing plate also had provision for the main chimney vent.

Figure 9. The top closing plate incorporating the chimney vent

The vent allows heat and condensation that can build up in the main part of the chimney to escape. A similar vent is normally provided in the register plate. The subsequent flow of air keeps the chimney cool and free from condensation. In most installations the chimney vent is drilled into the side of the chimney stack. However, due to the listed status of the property, the vent was incorporated into the top closing plate. A galvanised pipe was then inserted in to the vent hole to take the vent above the cement cap and any standing water that may accumulate inside the chimney pot.

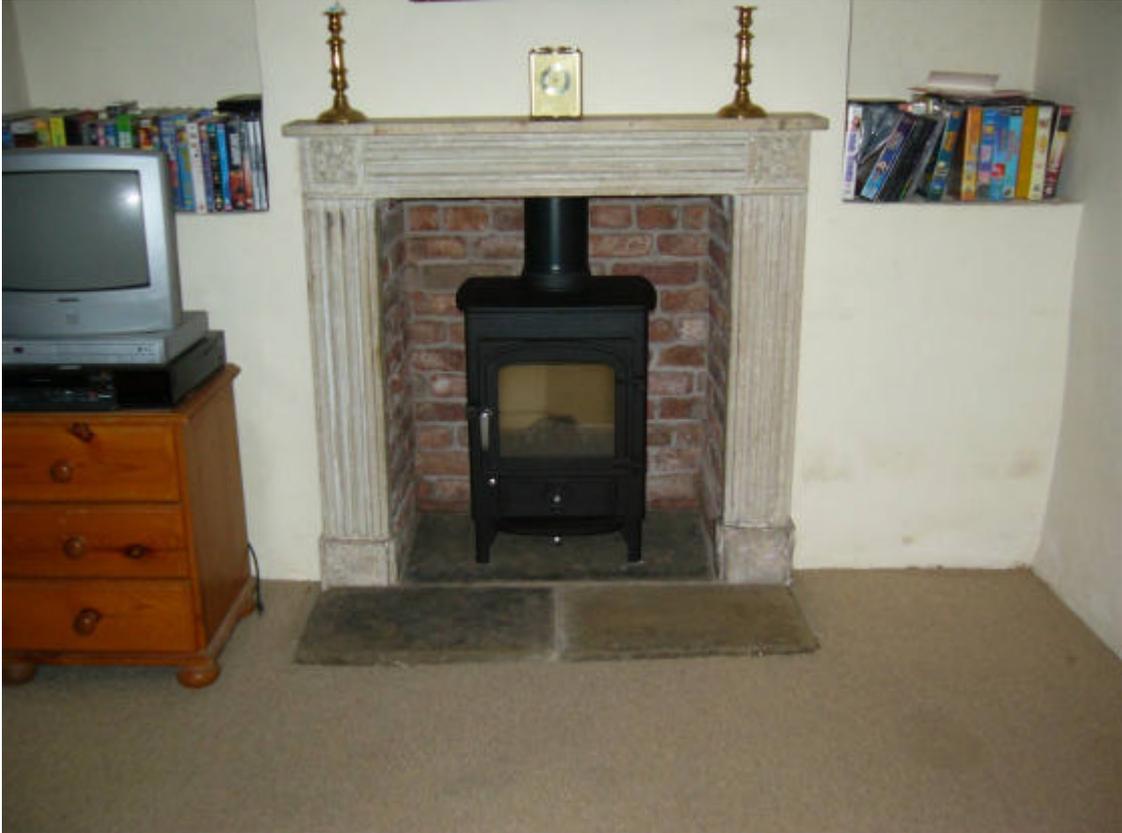
Figure 10 shows the completed fireplace with a 5kW Clearview Pioneer clean burning multi-fuel stove fitted.

Figure 10. Clearview stove.
